# Manhole Inspection Summary

Manhole # S35II\_036MH

Insp Date: **3/14/07 9:28 AM**

**Location** Address: **313 LANVALE ST**

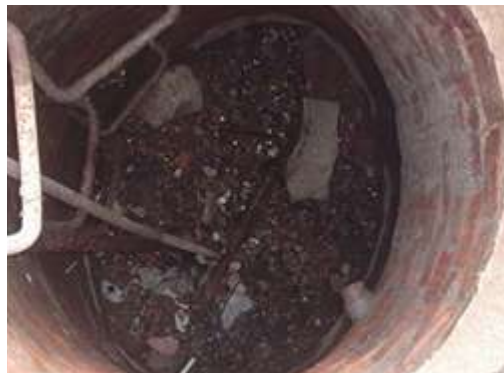
Top View

Corbel and Barrel infiltration. Corroded steps. Channel debris.

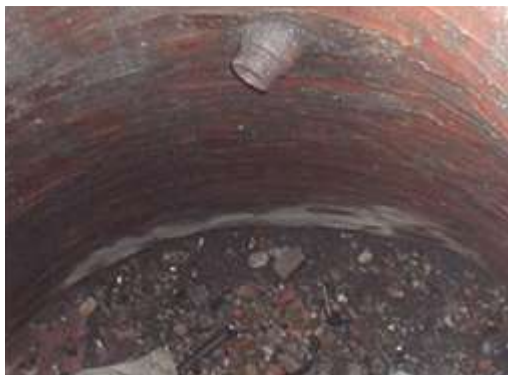
Defect

Valve at I5 - possible illicit connection

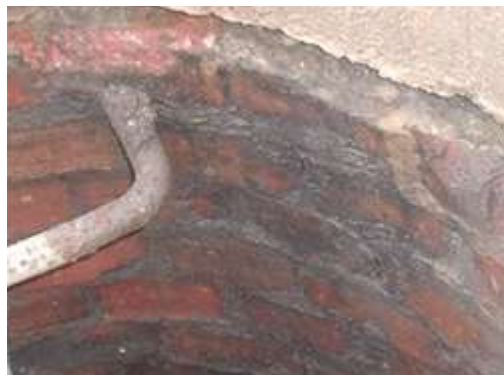
Defect

Frame leaks. Adjustment deterioration and infiltration.

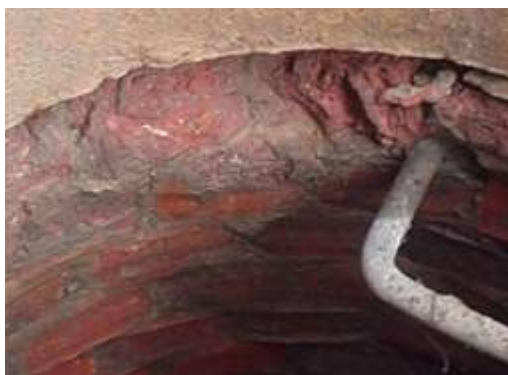
Frame leaks. Adjustment deterioration and infiltration.

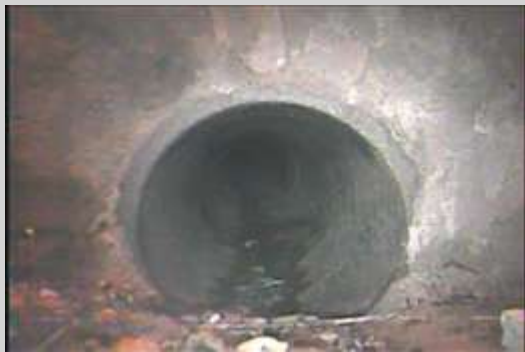
8 in. Circular Gravity Sewer  
Pipe Out @ 12 O'Clock

Pipe Material: **Clay** ☐ Pipe Lined

Invert Depth: **8.45** (ft.) Flow Characteristics: **None**

Infiltration: **None** Pipe Seal Cond: **Unknown**
